## Wear surface damage of a Stainless Steel EN 3358 aeronautical component subjected to sliding

Ferdinando Felli, Andrea Brotzu, Cristian Vendittozzi

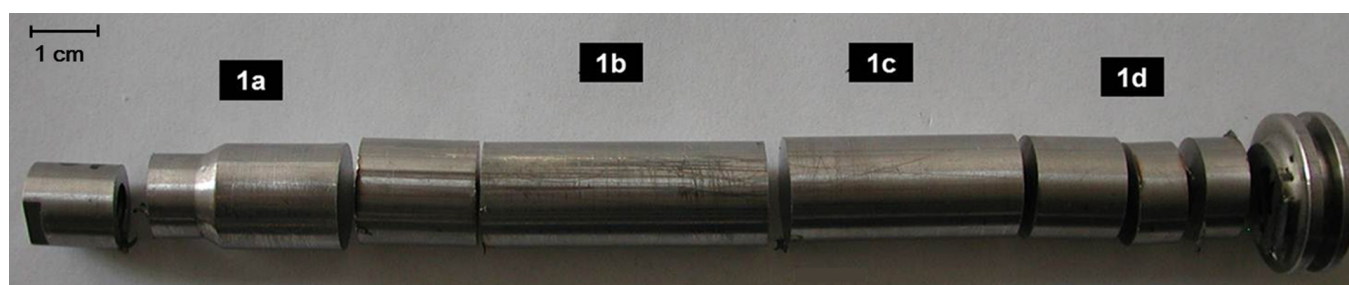
Figure 1: Sliding piston, sectioned in smaller samples for the failure analysis.

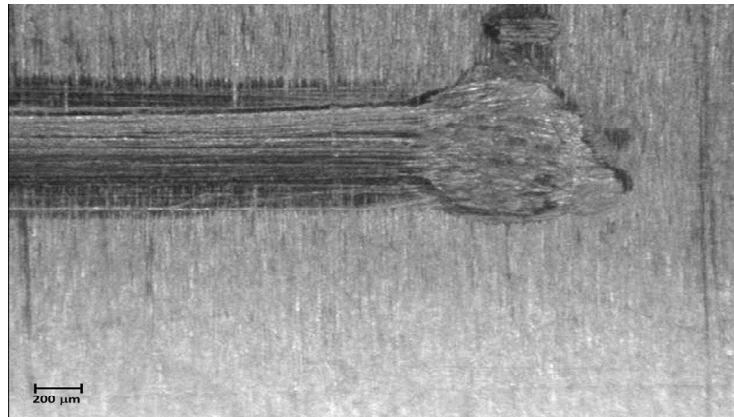
Figure 3: Sample 1, Piston, Longitudinal wear groove starting from one of the circular impressions.

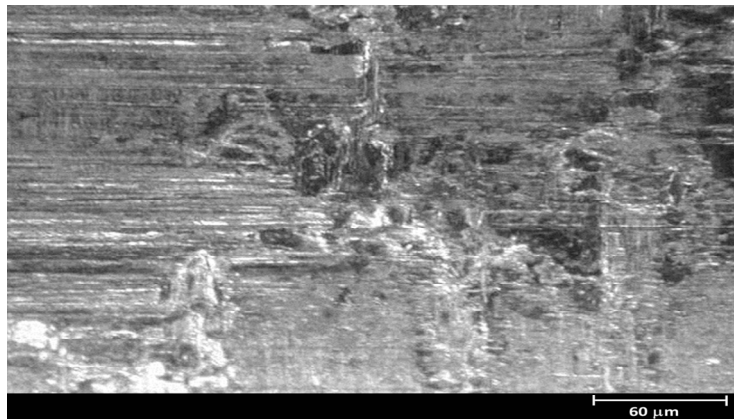
Figure 4: Sample 1, Piston, Scored area in the central part of the component.

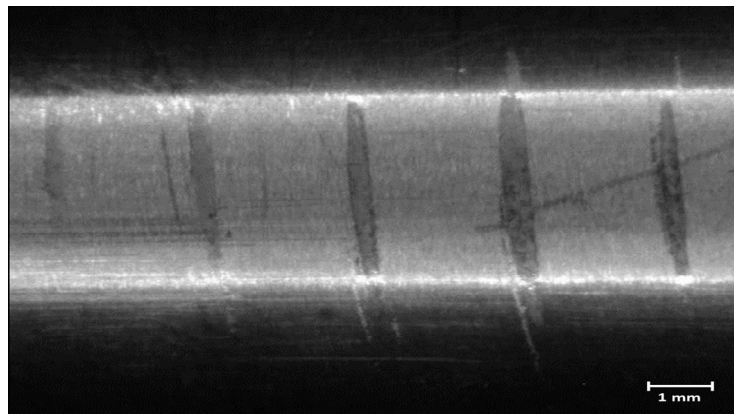
Figure 5: Sample 1, Piston, Helicoidal impressions produced by the spring.

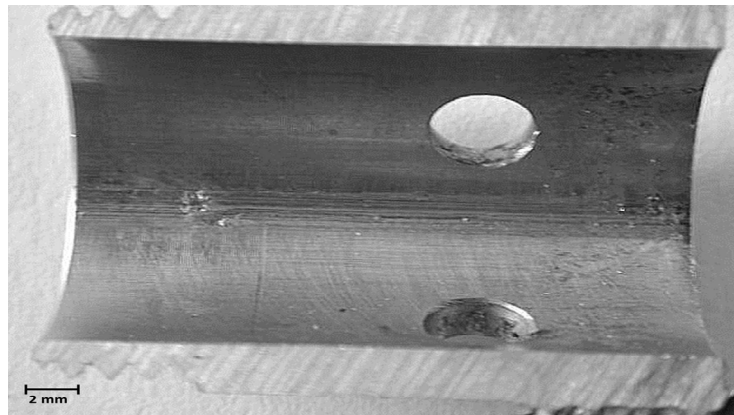
Figure 6: Sample 4, Nipple, Internal surface of the nipple with two of 4 holes and lubricant traces.

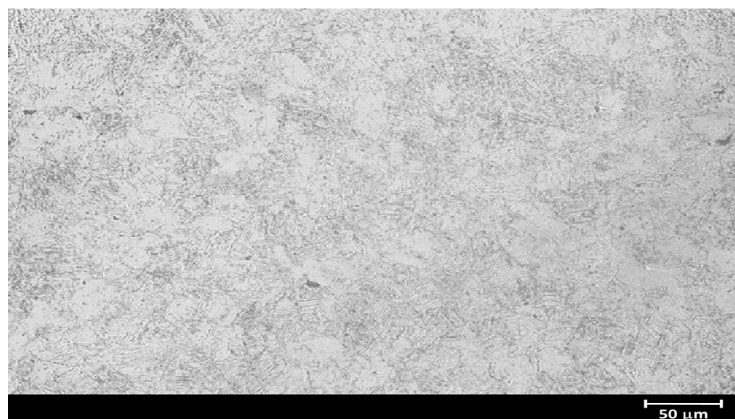
Figure 7: Microstructure of the PH stainless steel employed (piston and nipple).

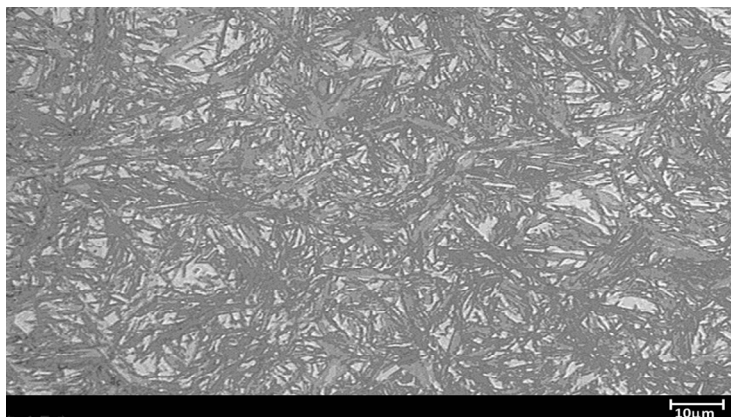
Figure 8: Microstructure of the Hypereutectoidic steel employed (locking spheres).

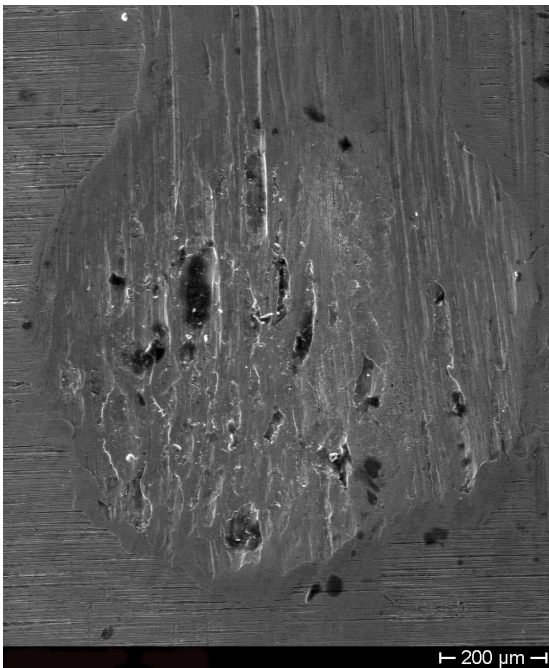
Figure 9: SEM micrograph of a circular impression found in the central part of the piston (sample 1).

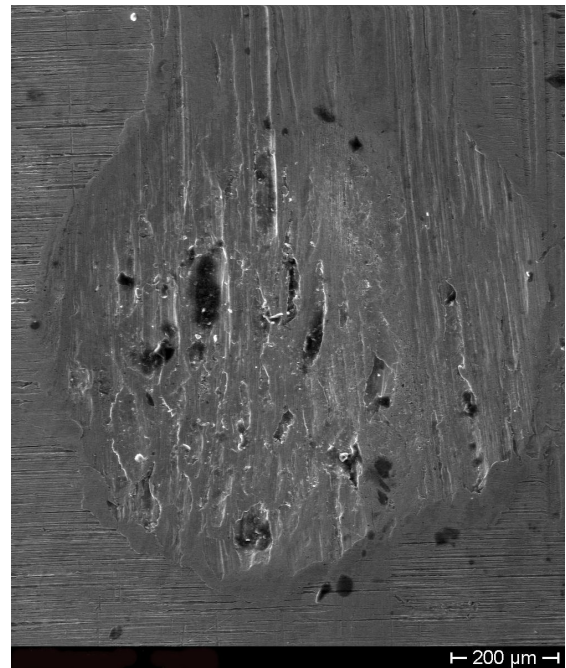
Figure 10: SEM micrograph of a longitudinal wear groove found in the central part of the piston (sample 1).

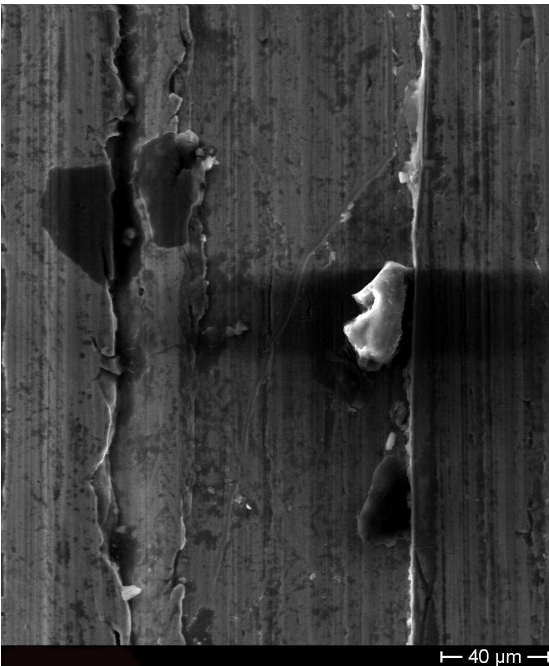
Figure 11: SEM micrograph of a longitudinal wear groove found in the central part of the piston (sample 1).

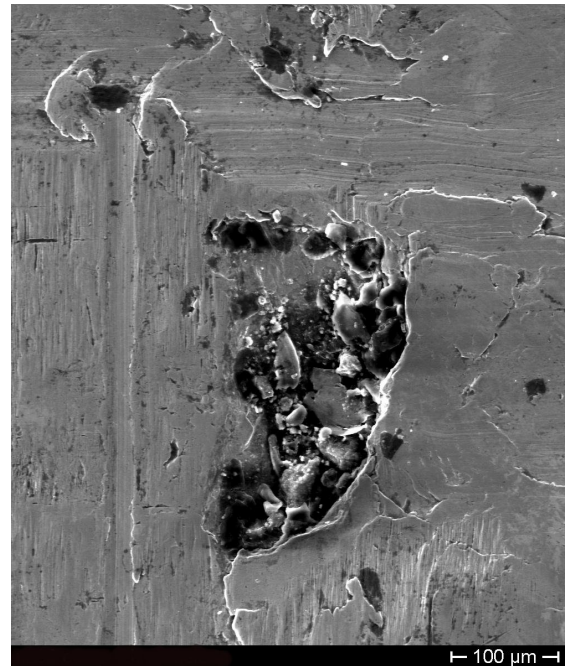
Figure 12: SEM micrograph of the scored area found in the central part of the piston (sample 1).

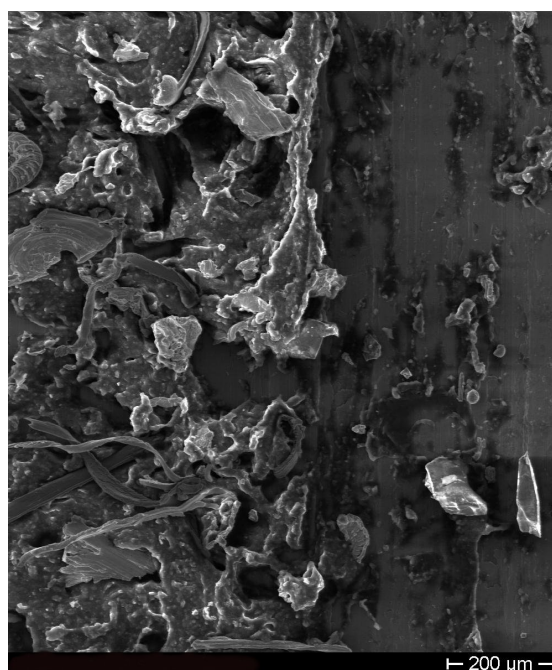
Figure 13: SEM micrograph of metallic debris inside a grease patch found in the internal surface of the nipple.
