The Influence of UHPFRC Jacket Steel Fiber Content on Strengthening Damaged Columns

ABSTRACT

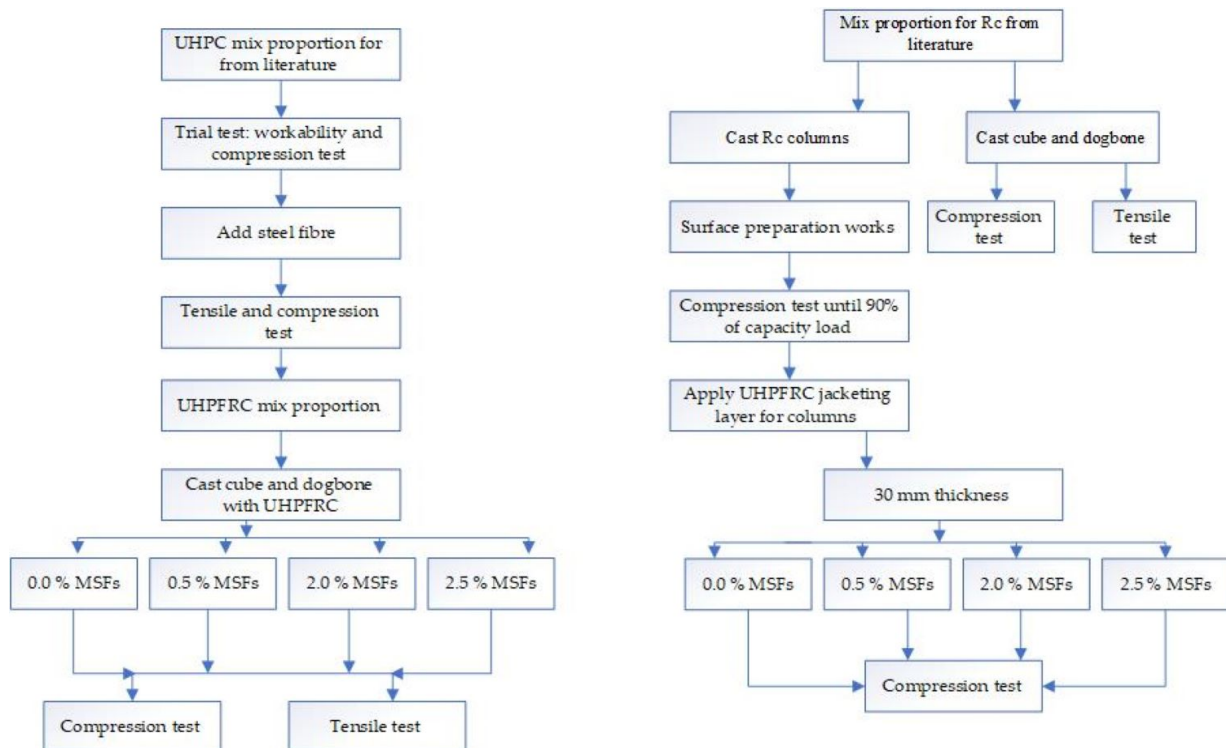
Fig. 1. The experimental research method.

This study investigated the effects of UHPFRC using MSF with a range of varying contents and aspect ratios as repair materials to strengthen and rehabilitate damaged columns subjected to overload. The columns were bonded on all four sides and jacketed with a fixed thickness of 30 mm. Figure 1 shows the framework of the experimental study.

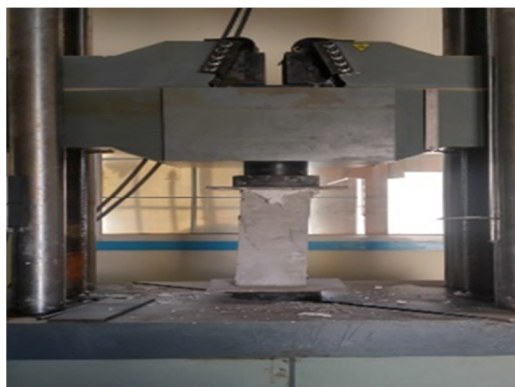
Fig. 5. Testing of concrete columns until 90% load compression damage.

Axial compression loads were applied to the columns using a hydraulic Universal Testing Machine (UTM) with a capacity of 200 tons. Steel plates were affixed to the upper and lower surfaces of each column to evenly distribute the axial load across the column. Before testing, the top surface was polished using a Gipson layer. A total of 12 RC columns were subjected to concentric axial compression loads at approximately 90% of their actual axial capacities, as shown in Figure 5, with a displacement rate of 0.5 mm/min until hairline cracks emerged, without reaching failure states. Among the 12 unrepaired columns, three exhibited the most promising values and were selected as control samples. Data were recorded through a computer system connected to the testing machine.

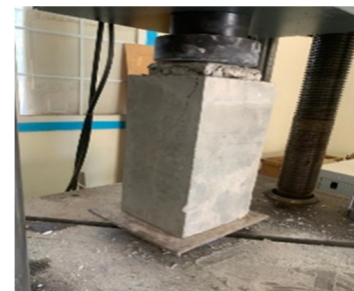
Fig. 7. Testing of concrete column damage after using the repaired material.

Based on the test variables shown in Table III, the columns were sorted into five groups. The first group (Co 0) was prepared from the normal concrete mix (M 0) and the three best of the 12 unrepaired columns were chosen as control specimens. In the second group (Co 1), three columns were strengthened with MSF-free UHPRC jacketing to study its effect on column behavior. In the rest of the groups (Co 2, Co

3, and Co 4), three columns in each group were strengthened by UHPFRC jacketing with MSF content of 0.5, 2.0, and 2.5% to study its effect on columns' behavior. All mixed groups were used to cast the column damage and the 100-mm cube. Columns and cubes were cured in water for 28 days and then kept in air at room temperature until the test day. All repaired specimens with UHPFRC were tested under axial compression with a displacement rate of 1 mm/min, as recommended in [17], until cracks appeared and the specimens failed, as shown in Figure 7. The average of the three-column specimens was considered during the loading process. Axial load and vertical displacement data were recorded through a computer system connected to the machine, and then the vertical load-displacement curve was plotted, which led to the determination of the ultimate load, displacement, and ductility. The crack patterns and the failure modes were determined throughout the experiment.

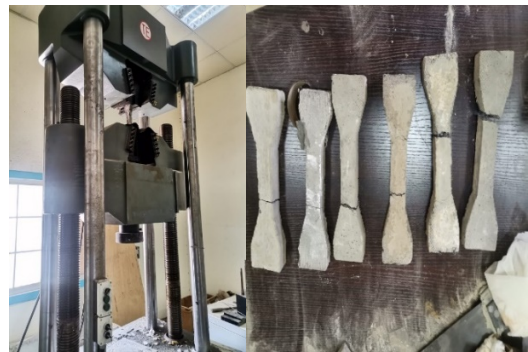
Fig. 8. Experimental tensile test of dogbones.

Table IV summarizes the properties of concrete mixes with and without UHPFRC jacketing. Compressive strength was obtained by testing three standard test cubes (100×100×100 mm) at the end of 28 days. The increase in MSF content in repair concrete also led to increased tensile and compressive strengths (f_{tu} and f_{cu}). At the testing date, after 28 days from casting, the f_{tu} and f_{cu} of M 0 for reinforcement concrete were 37.3 MPa and 2.41 Mpa, respectively. Since the MSF content
